## Engine TROUBLE and potential SAFETY disaster!

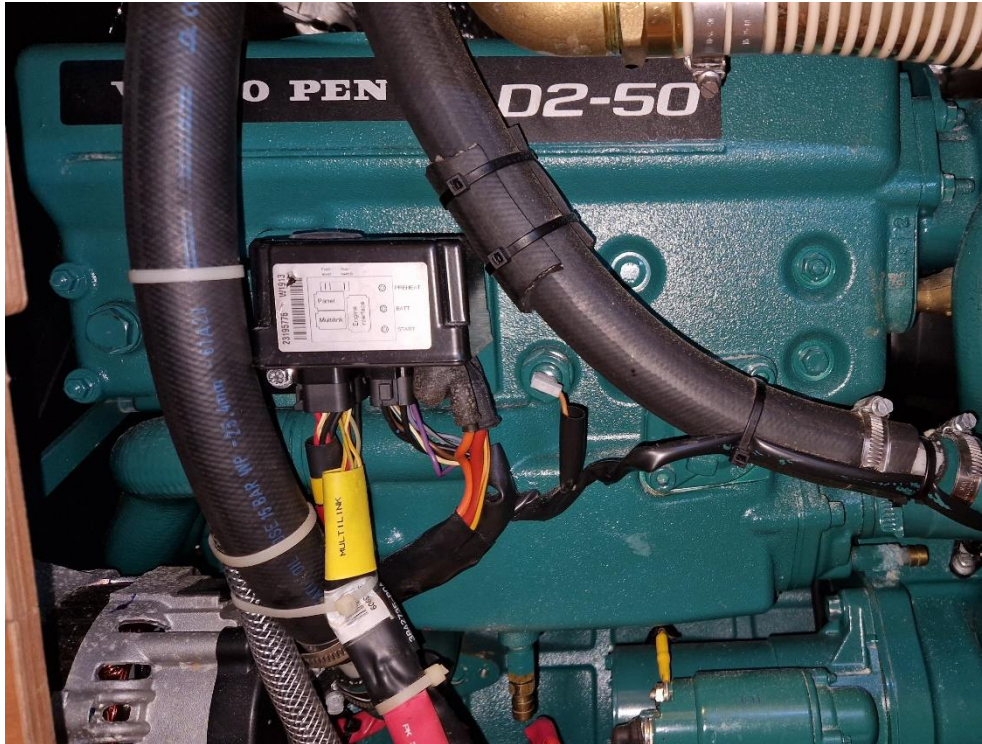
MDI control unit as standard mounted on engine. Vibrations and heat!

However, the MDI had other plans and surprises for us. After about half an hour the engine suddenly decreased its running rpm speed and then speeded up again and this continued several times. The display in the round RPM instrument showed the STOP symbol flashing up a little now and then when the rpm decreased and this is exactly the symbol that usually comes up when pressing the STOP button, ie when the MDI is in shut engine down mode. After a while everything seemed normal and we were happy the engine did not stop but this happiness did not last for long because suddenly the engine stopped. Luckily the starting panel was not dead this time and the engine started when pressing the START button. For the rest of the trip the engine worked fine and we moored in our home port. Now it was not possible to stop the engine by using the STOP button at first but after some attempts it suddenly worked and the engine was stopped electronically. As we all know the engine can be stopped mechanically with the lever on the fuel injection pump but this was not needed this time.

When searching the internet I found several articles about the problems with the MDI unit and many frustrated and upset users where some changed the MDI several times. Obviously this is a well-known problem and it seems it is continuing even after several upgrade revisions by Volvo Penta. We had the latest version, #23195776 label on our MDI, while the ordering number for some strange reason is #23231607. A new MDI had a price of around EUR 700 but we were lucky the engine had 5 years extended warranty for some types of faults and we got a new MDI without cost from Volvo Penta or maybe it was goodwill from their side.

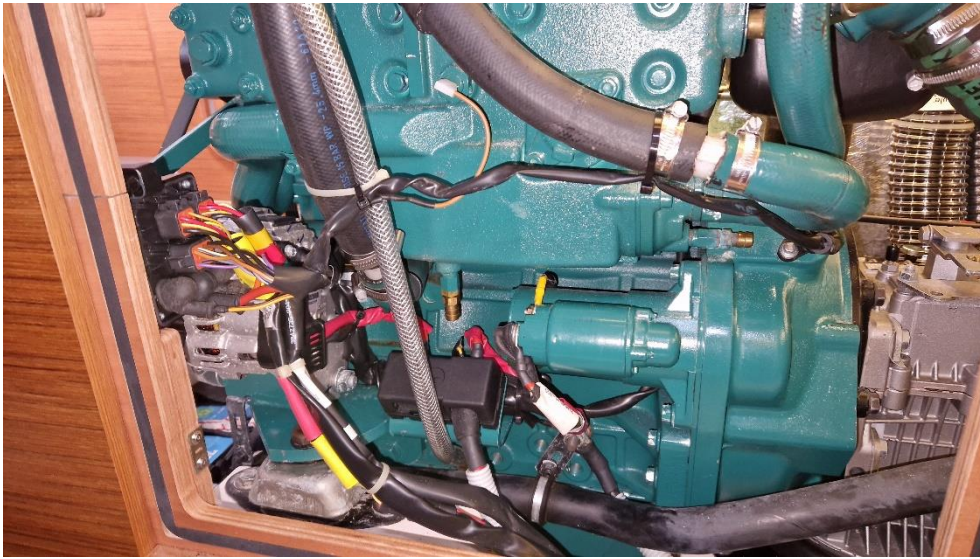
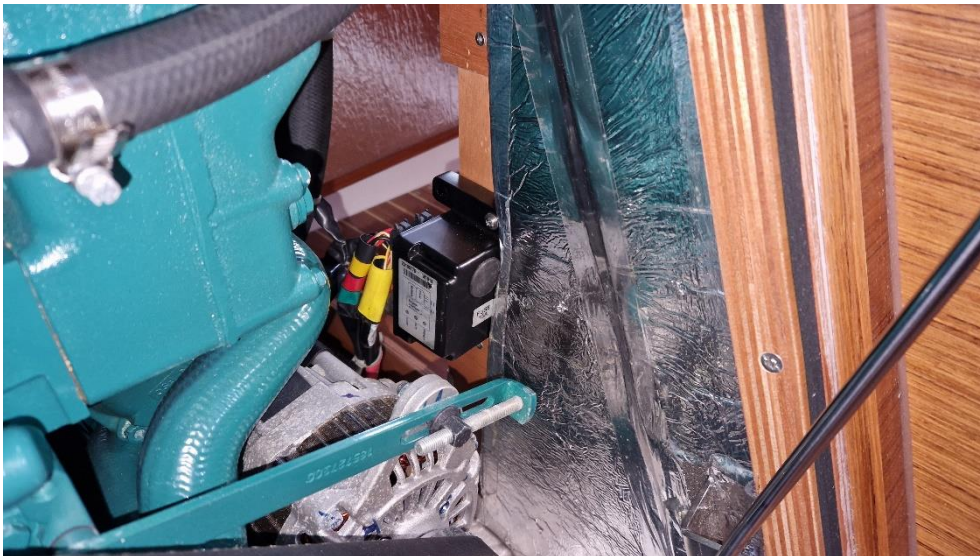
MDI control unit mounted on engine room bulkhead

The new MDI was mounted on the engine room bulkhead to decrease vibrations and heat. The harness was long enough and only the brown cable for the water temperature had to be extended.

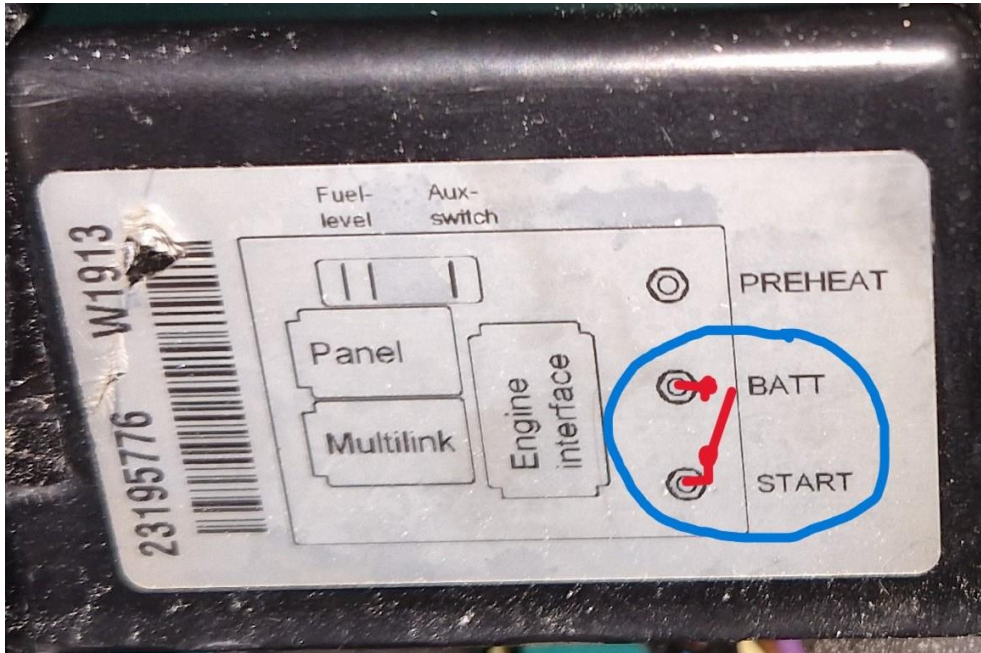
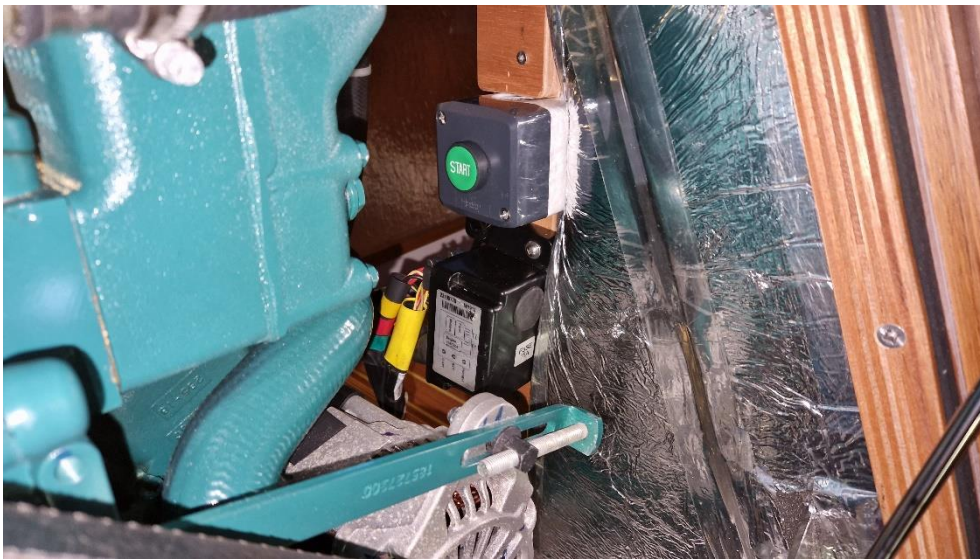
Emergency START button

Added an emergency start button bypassing the MDI with a button connecting the MDI "BATT" and "START" connectors. Seems to be a diode or similar inside the MDI (ohm resistance measured) so the current does not go backwards into the MDI but to the start solenoid.
